# ANNUAL REPORT FOR 2003

**Cedar Point Mitigation Site**  
**Carteret County**  
**Project No. 6.16901T**  
**TIP No. R-2105 AB**

Prepared By:  
Office of Natural Environment & Roadside Environmental Unit  
North Carolina Department of Transportation  
December 2003

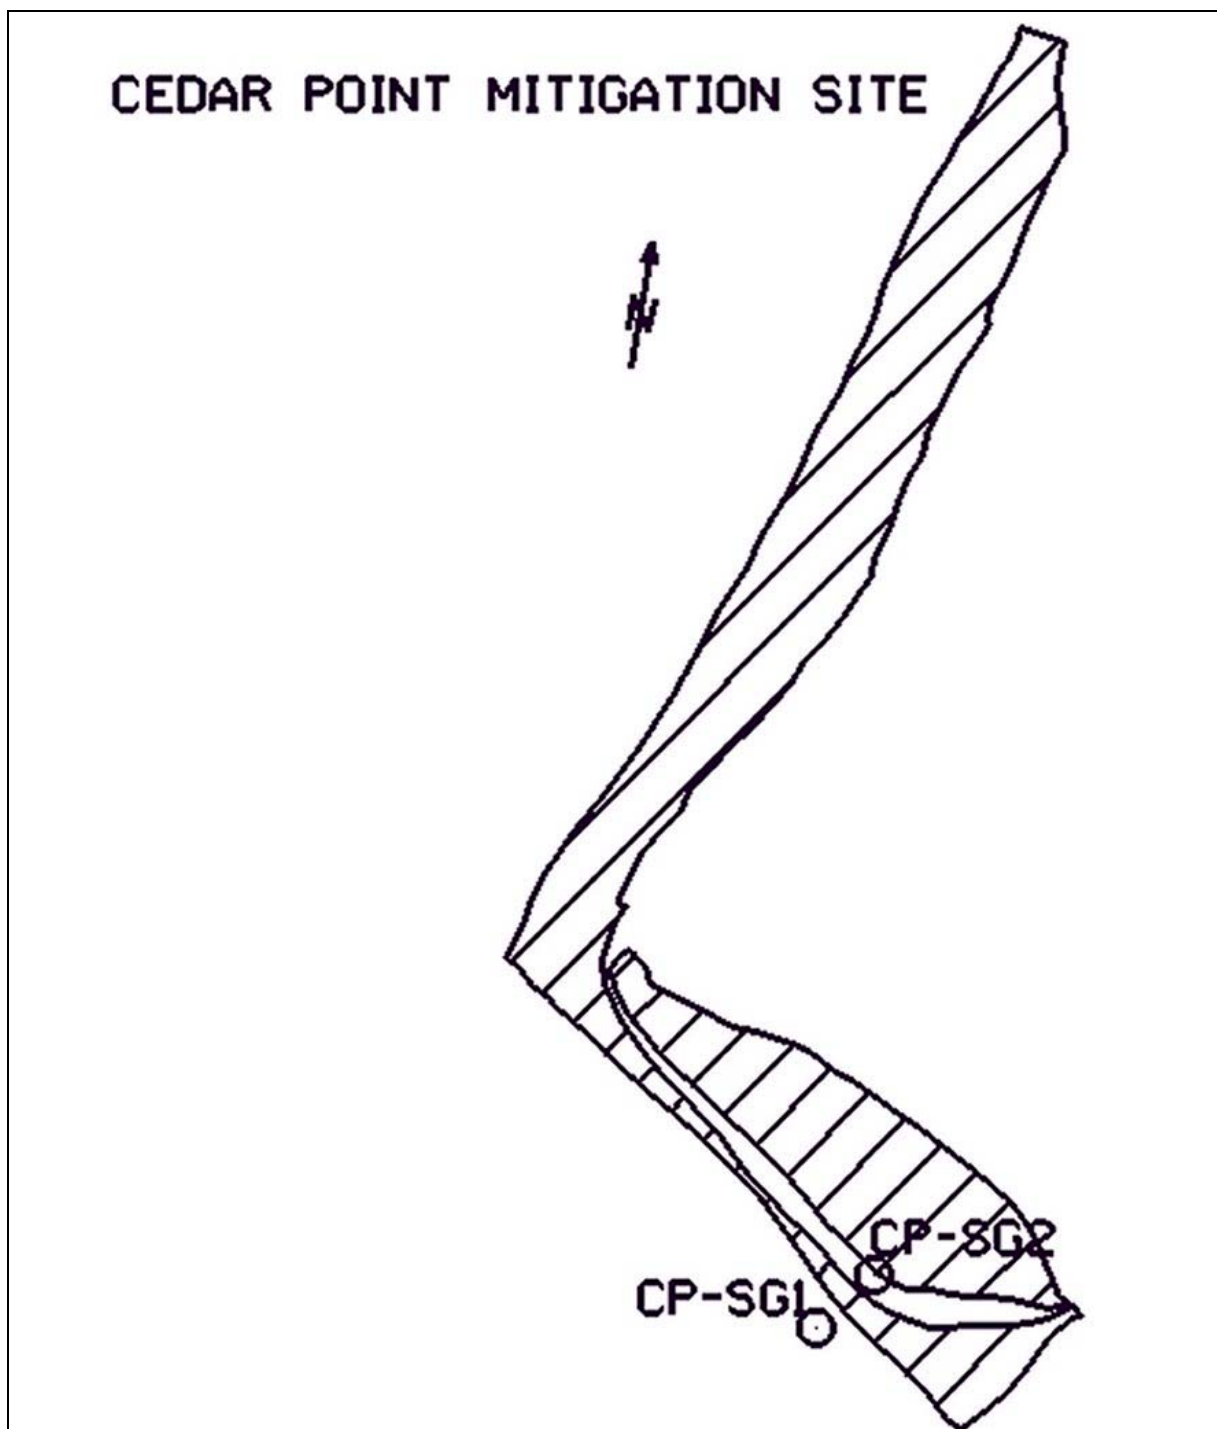
Figure 2. Gauge Location Map

Due to the site's proximity to the White Oak River, as well as the constructed channel designed to increase tidal exchange, the Cedar Point Site is monitored by surface water gauges (Figure 2). These gauges should indicate if the site is flooded twice daily as is required for success. The flooding regime of the site is expected to be the same as that measured for the biological benchmarks for *Spartina alterniflora*, since it can reflect long-term tidal fluctuations. A rain gauge was not installed as surface water is the primary hydrologic input to this site.

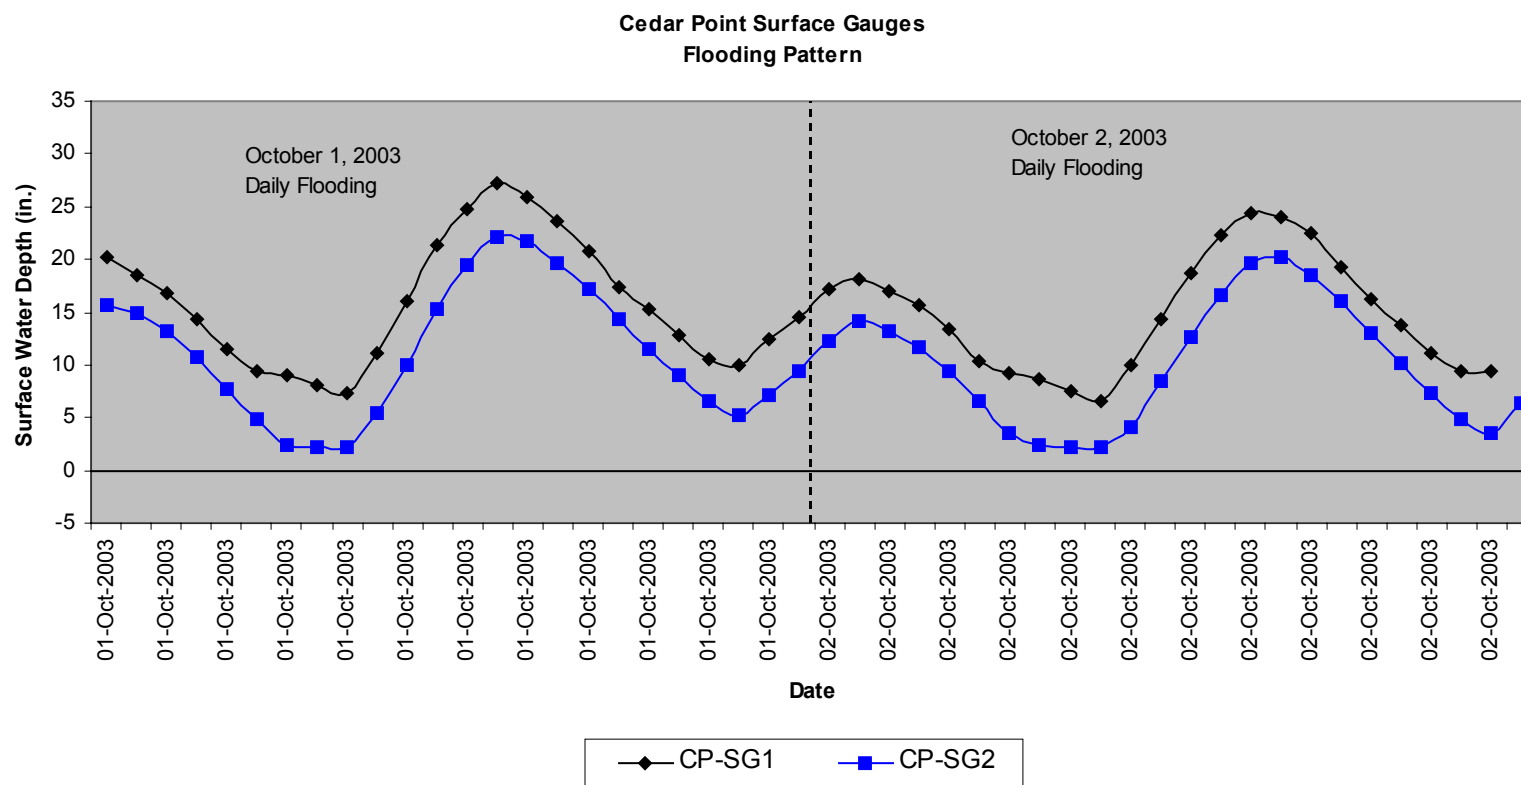
Figure 3. Plot of Daily Flooding Pattern (2-day period shown)

Figure 3 is a surface water plot of the data recorded at both gauges over a two-day period (selected at random). This figure is to illustrate that flooding occurs twice daily as required in the permit conditions. The two days in the plot were chosen at random and are representative of conditions throughout the growing season.

The surface gauges indicate that the site is being flooded twice daily during the growing season. An examination of the water levels over a two-day period (Figure 3) illustrates that the site floods twice daily in average to above average climatic conditions (as required for success criteria). The two days in the plot were chosen at random and are representative of typical conditions during the growing season.

Data interruptions (July 28-September 23) were caused by limitations in the storage capabilities of the surface gauges. Currently, the surface gauges are set to record hourly water levels. Future downloads will reflect 3-hour intervals, thus alleviating the data interruption problem. Gauge (SG-1) was found washed away; therefore, the gauge was not downloaded for the period from March 13-July 27.

Data interruptions from both surface gauges (July 28-September 23) were caused by limitations in the storage capabilities of the gauges. Currently, the surface gauges are set to record hourly water levels. Future downloads will reflect 3-hour intervals, thus alleviating the data interruption problem.

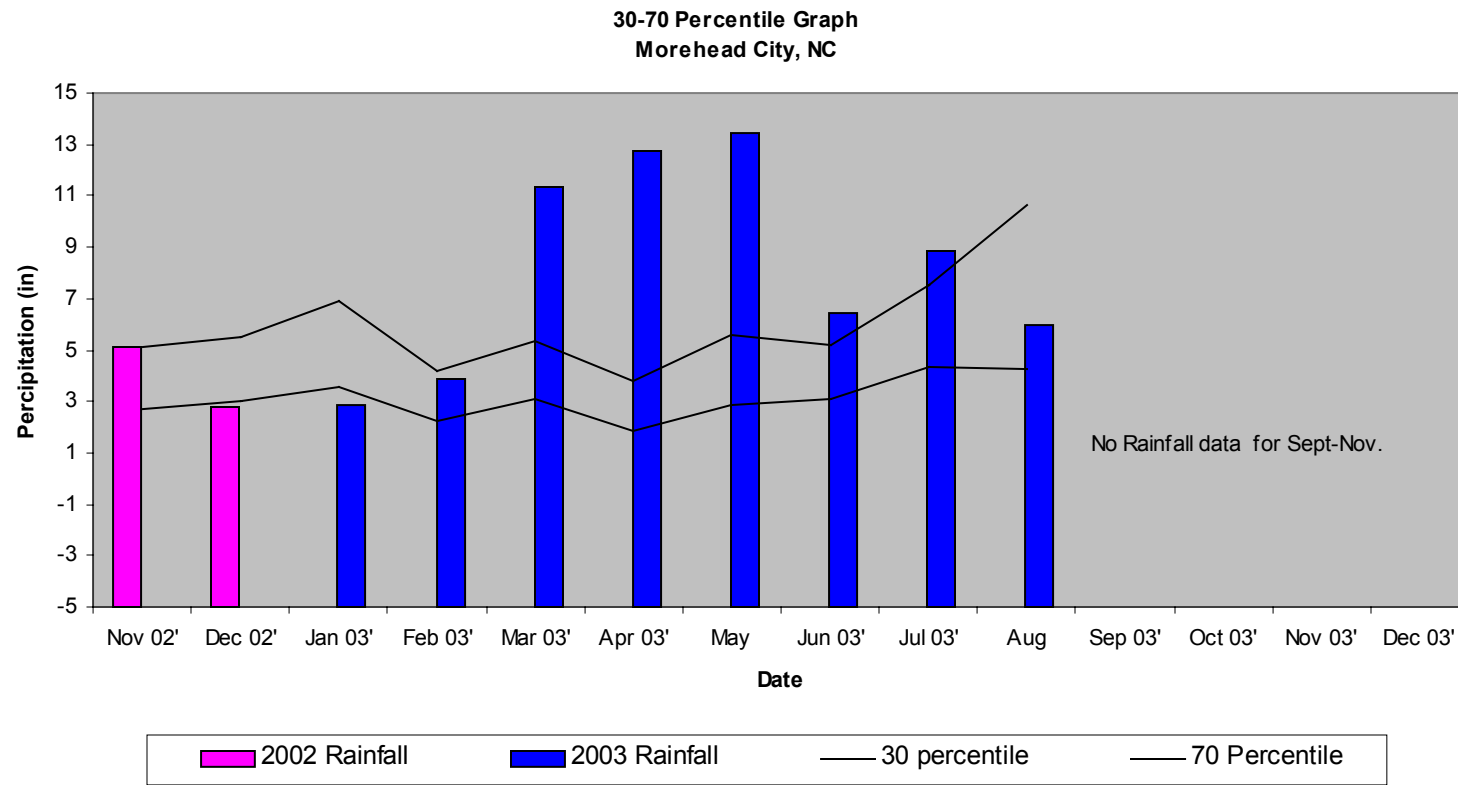
Figure 4. 30-70 Percentile Graph

Figure 4 is a comparison of monthly rainfall (November 2002- August 2003) to historical precipitation for the area. The rainfall data for the months of (September-November 2003) were not included in the graph. The two lines represent the 30<sup>th</sup> and 70<sup>th</sup> percentiles of monthly precipitation for Morehead City, NC. These percentiles represent monthly rainfall data collected between 1972 and 2003 that was provided by the State Climate Office of North Carolina at NC State University.

For the 2003-year, March, April, May, June, July, September, and October experienced above average rainfall. The months of December (02') and January recorded below average rainfall for the site. November (02'), February, August, and November experienced average rainfall. Overall, the site met hydrologic criteria in a year of average to above average climate conditions. However, precipitation is not the primary hydrologic input for the site; thus, it is expected that the site would show the required flooding regardless of area rainfall totals.
